**SUBJECT: MINE HILL CREEK PLAT**

## Fish Passage & Diversion Screening Inventory Database Report Cover Sheet

## Level A Culvert Assessment Report

## Image Report - Active

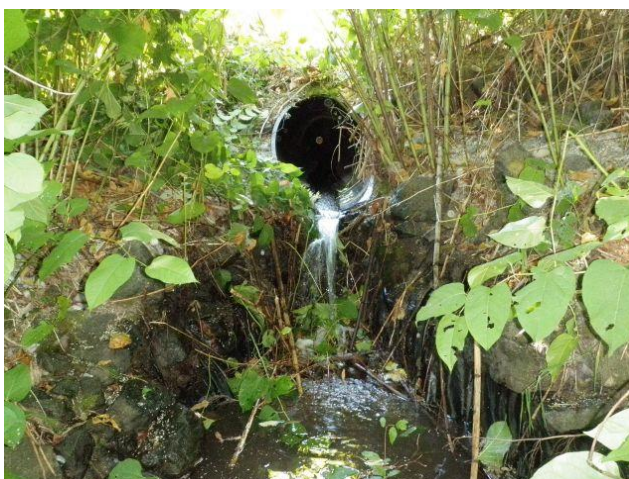
Culvert Details							Level A Parameters					
ID	Shape	Material	Span	Rise	Length	WDIC	Apron	WSDrop	Location	Countersunk	Backwater	Slope (%)
1.1	RND	PVC	1.03	1.03	84.40	0.02	NO	0.82	Outlet	No	0	7.42

<b>Assessment Results</b>			
Barrier:	Yes	Passability (%):	0
Reason:	WS Drop	Fishway Present:	No
		Method:	Level A
		Recheck:

<b>Comments</b>
US culvert has an attached standpipe with a trash rack on the culvert and standpipe. Concrete wingwalls and headwalls US. DS outfall onto boulders.
